**Flood Control Project Maintenance
Levee Inspections**
LMA District Cover Sheet
Spring 2019 Levee Inspection Results

Reclamation District No. 0544 Upper Roberts Island

Waterway			Bank	Unit Miles
Unit No. 01 San Joaquin River			Left	6.05
	Spring (March - May)	Summer (June - August)	(September - November) Fall	Winter (December - February)
Unit Maintenance Rating (Fall Only)				
Date of Inspection	5/9/2019 - 5/9/2019			
DWR Inspector	Alberto De Leon			
Accompanied By	Jerry Robinson

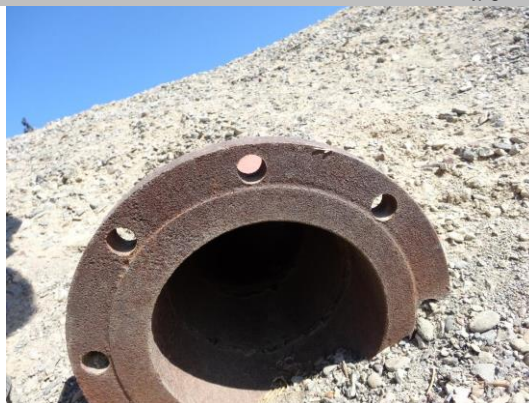
Photo 1 of 3 : UCIP_SP_2019_46674_44890.jpg

LM Start	1.38	Rating **	M	Issue No.	104
LM End	1.38	Issue Type +	En	Location *	
Category	Supplemental			GPS Latitude/Longitude	
				Start	End
Item	DWR UCIP Field Study			37.821380 °	37.821380 °
				-121.337835 °	-121.337835 °
DWR ID	22668				
Comment Code					
Inspector Comment					
FS_ID:46674 DS_ID:22668 EP_NO: N/A Repair Type: Non-Urgent Crossing Status: Found UCIP Comments: - slope erosion on landside. FIELD_STRUCT_DESC: 8-inch pipe of an unknown material or purpose through the levee, 3.5 feet below the crown. Pipe open on both ends, 1991. Steel pipe riser on the landside (LS), but not sure whether it is connected to the pipe. [Additional Reference(s): DWR Levee Log, 2005]. FS Date: 10/31/2013

WS view: steel pipe on levee slope with opened end.

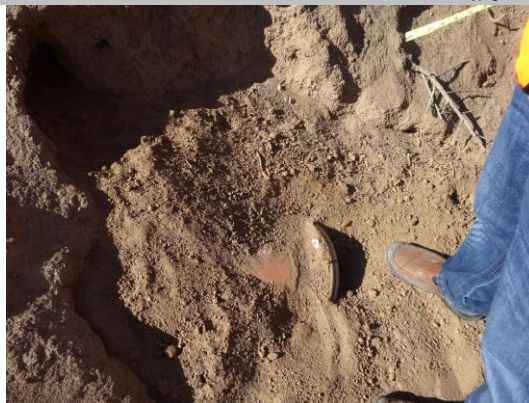
Photo 2 of 3 : UCIP_SP_2019_46674_44889.jpg

LS view: steel pipe on levee slope with opened end. Levee slope erosion around the pipe.

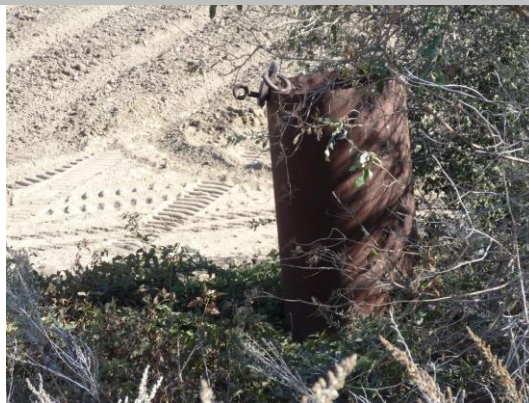
Photo 3 of 3 : UCIP_SP_2019_46674_44888.jpg

LS view: steel pipe riser off the levee toe.

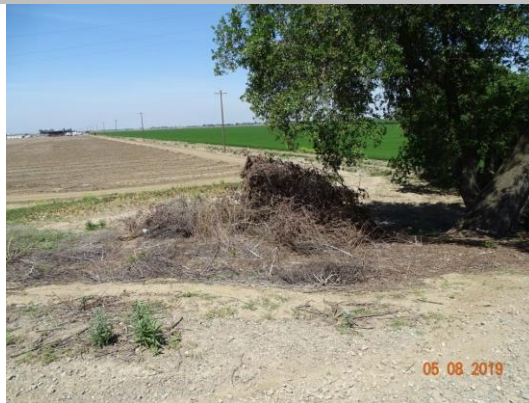
Photo 1 of 1 : SP_2019_RD0544_109_26_20190523_00119.jpg

LM Start	1.40	Rating **	U	Issue No.	26
LM End	1.40	Issue Type +	En	Location *	LS
Category	Earthen Levee			GPS Latitude/Longitude	
				Start	End
Item	Encroachments			37.821577 °	37.821577 °
				-121.338211 °	-121.338211 °
DWR ID	DWR_RD0544_02_s_2019_26				
Comment Code					
PR : Prunings					
Inspector Comment

View of prunings on landside slope. (Spring 2019)

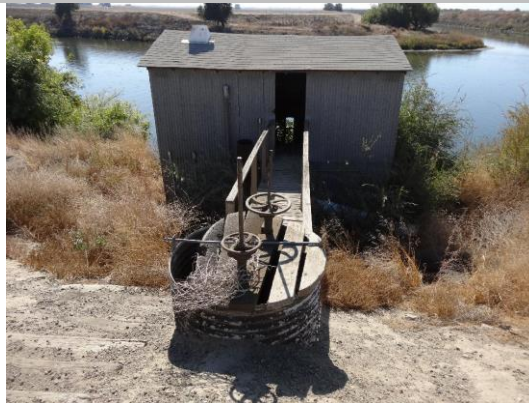
Photo 1 of 3 : UCIP_SP_2019_24288_42947.jpg

Comment Code					
Inspector Comment					
FS_ID:24288 DS_ID:22669 EP_NO: N/A Repair Type: Non-Urgent Crossing Status: Found UCIP Comments: - two pumps with 16" steel pipe and an abandoned pump with 10" pipe inside pump house.- CMP riser cover needs repair. - electric conduits on waterside and power pole on landside. FIELD_STRUCT_DESC: 24-inch steel irrigation discharge pipe through the levee, 14 feet below the crown. Pump in a pump house on the waterside (WS) berm. Slide gate in a corrugated metal pipe (CMP) riser on the WS slope. Two corrugated metal cutoff walls. Distribution box and power pole at the landside (LS) toe. [Additional Reference(s): DWR Levee Log, 2005. USACE San Joaquin O&M Manual 7, April 1964, (HLM 1.53)]. FS Date: 10/31/2013

WS view: slide gate in CMP riser, walkway, and pumphouse on levee slope.

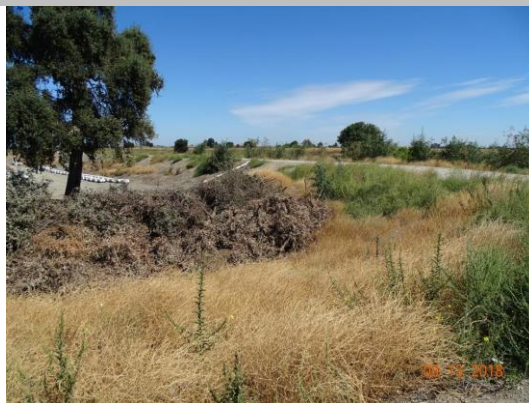
Photo 1 of 2 : SP_2019_RD0544_109_31_20190313_00022.jpg

LM Start	1.90	Rating **	U	Issue No.	31
LM End	1.94	Issue Type +	En	Location *	LS
Category	Earthen Levee			GPS Latitude/Longitude	
				Start	End
Item	Encroachments			37.817582 °	37.817994 °
				-121.342125 °	-121.342500 °
DWR ID	DWR_RD0544_02_f_2018_31				
Comment Code					
PR : Prunings					
Inspector Comment					
Large pruning pile at landward toe.

Looking northwest at large pruning pile at landward toe. (Fall 2018)

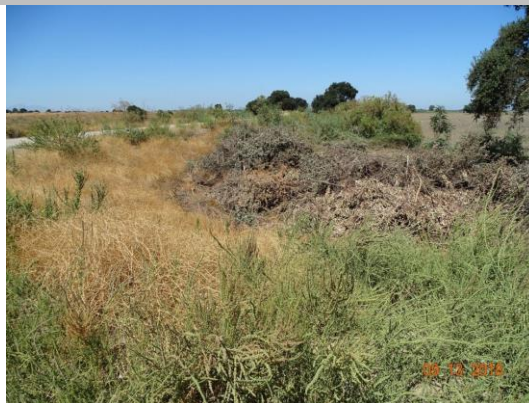
Photo 2 of 2 : SP_2019_RD0544_109_31_20190313_00023.jpg

Looking south at large pruning pile at landward toe. (Fall 2018)

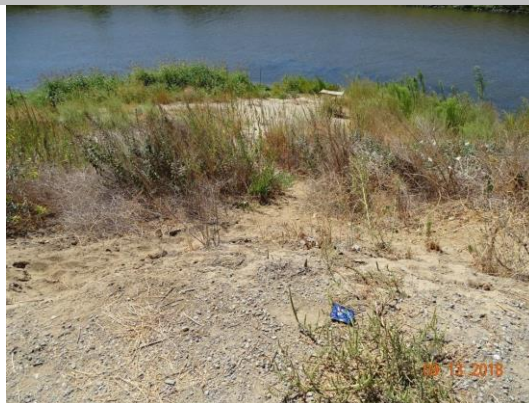
Photo 1 of 2 : SP_2019_RD0544_109_34_20190313_00024.jpg

LM Start	1.91	Rating **	M	Issue No.	34
LM End	1.91	Issue Type +	Ma	Location *	WS
Category	Earthen Levee			GPS Latitude/Longitude	
				Start	End
Item	Erosion / Bank Caving			37.817658 °	37.817658 °
				-121.342097 °	-121.342097 °
DWR ID	DWR_RD0544_02_f_2018_34				
Comment Code					
E1 : Note and monitor erosion site.					
Inspector Comment					
Erosion is caused by foot traffic.

Looking east at foot erosion on waterward slope. (Fall 2018)

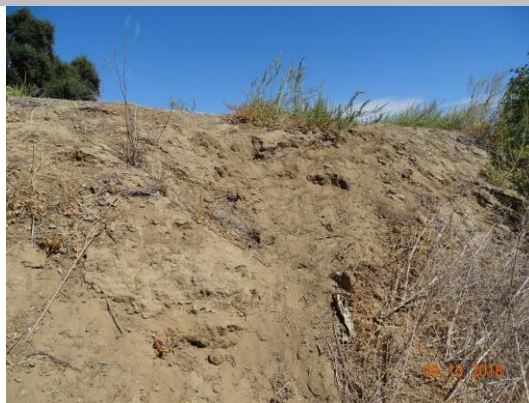
Photo 2 of 2 : SP_2019_RD0544_109_34_20190313_00025.jpg

Looking west at erosion on waterward slope. (Fall 2018)

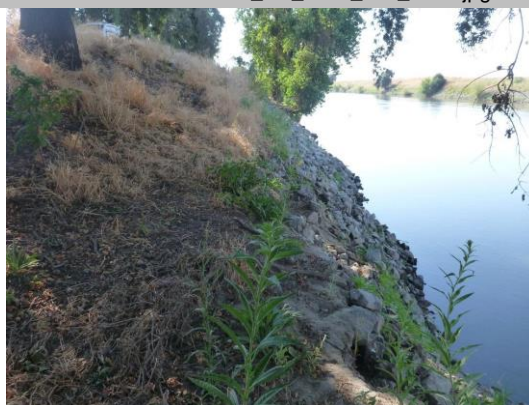
Photo 1 of 3 : LEVAL_SP_2019_551_4817.jpg

LM Start	2.17	Rating **	A/W	Issue No.	87
LM End	2.18	Issue Type +	Ma	Location *	
Category	Supplemental			GPS Latitude/Longitude	
				Start	End
Item	2017 Storm Damage			37.820300 °	37.820300 °
				-121.345600 °	-121.345700 °
DWR ID	DWR_RD0544_02_f_2017_87				
Comment Code					
Inspector Comment					
Levee Evaluation Comments					
Description:Slope protection repairs are needed along the waterside slope due to erosion and riprap displacement from high water. Based upon levee inspections, it was determined the waterside levee slope is eroding, deteriorating, and degrading. The eroded levee sections need to be restored back to design standards to prevent further deterioration and damage.					
Site ID No:551					
Site Designation:LMA-457					
Repair Type: Erosion					
Rating:Serious					
Field Date:8/18/2017					
Notes:

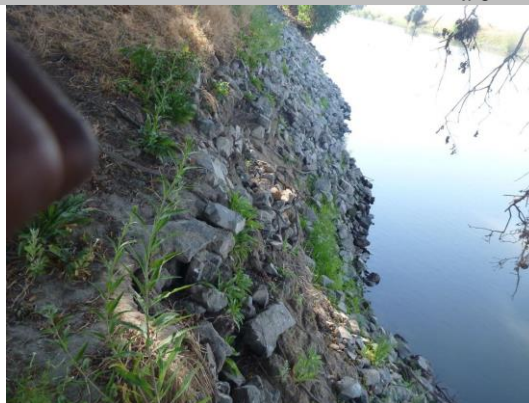
Photo 2 of 3 : LEVAL_SP_2019_551_4818.jpg

LM Start	2.17	Rating **	A/W	Issue No.	87 (cont)
LM End	2.18	Issue Type +	Ma	Location *	
Category	Supplemental			GPS Latitude/Longitude	
				Start	End
Item	2017 Storm Damage			37.820300 °	37.820300 °
				-121.345600 °	-121.345700 °
DWR ID	DWR_RD0544_02_f_2017_87				
Comment Code					
Inspector Comment					
Levee Evaluation Comments					
Description:Slope protection repairs are needed along the waterside slope due to erosion and riprap displacement from high water. Based upon levee inspections, it was determined the waterside levee slope is eroding, deteriorating, and degrading. The eroded levee sections need to be restored back to design standards to prevent further deterioration and damage.					
Site ID No:551					
Site Designation:LMA-457					
Repair Type: Erosion					
Rating:Serious					
Field Date:8/18/2017					
Notes:

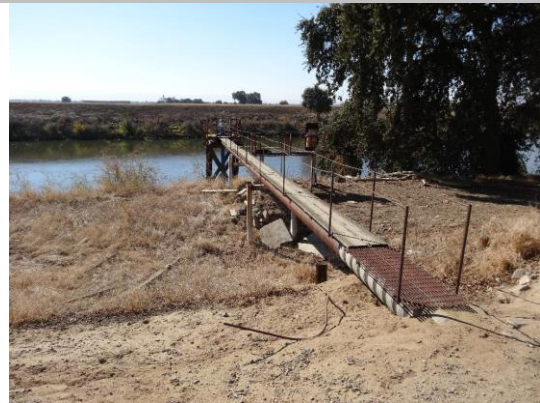
Photo 1 of 3 : UCIP_SP_2019_41731_42954.jpg

Comment Code						
Inspector Comment						
FS_ID:41731 DS_ID:22675 EP_NO: N/A Repair Type: Non-Urgent Crossing Status: Found UCIP Comments: - soil erosion on landside slope.- new pump and pipe (according to the owner- three months old)- electric conduit through levee, service pole on landside. FIELD_STRUCT_DESC: 16-inch steel irrigation discharge pipe and electrical conduit through the levee, 3 feet below the crown. Pump on a pile structure in the stream. Pressure breaker on the landside (LS) slope. Pipe exposed on both slopes and on the berm. [Additional Reference(s): DWR Levee Log, 2005, 12-inch pipe referenced. USACE San Joaquin O&M Manual 7, April 1964, (HLM 2.25), 12-inch pipe referenced]. FS Date: 10/31/2013

WS view: pipe, walkway, and pump on pile structure.

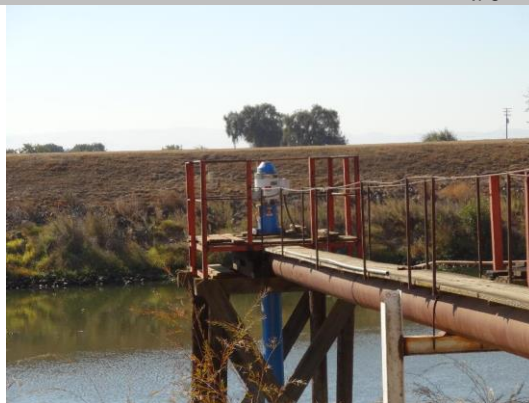
Photo 2 of 3 : UCIP_SP_2019_41731_42953.jpg

WS view: closer view of pipe, walkway, and pump on pile structure.

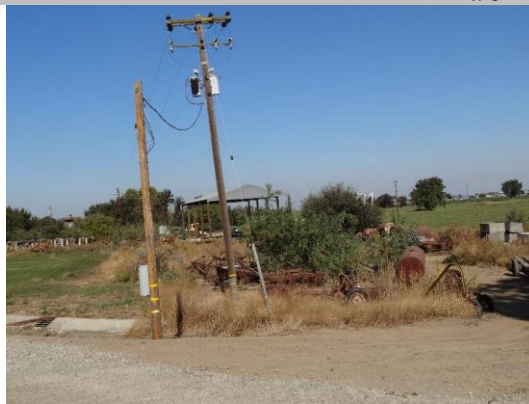
Photo 3 of 3 : UCIP_SP_2019_41731_42957.jpg

LS view: service pole on levee slope.

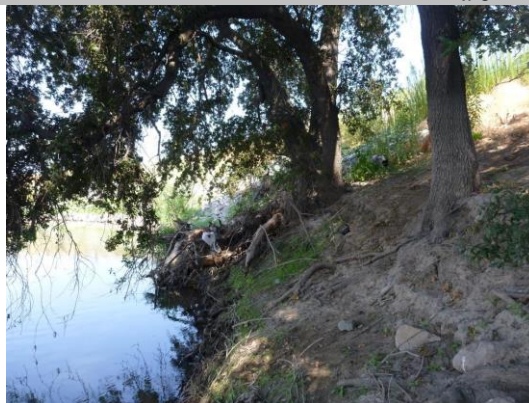
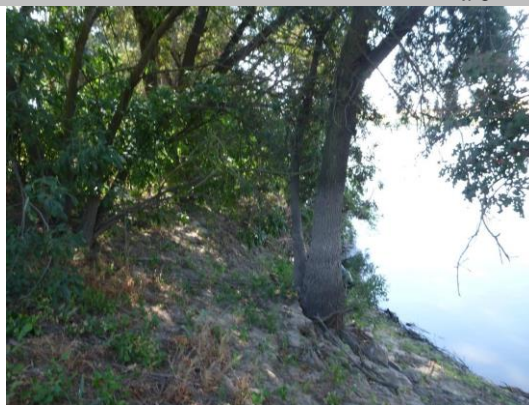
LM Start	2.32	Rating **	A/W	Issue No.	89 (cont)
LM End	2.33	Issue Type +	Ma	Location *	
Category	Supplemental			GPS Latitude/Longitude	
				Start	End
Item	2017 Storm Damage			37.821800 °	37.821900 °
				-121.347500 °	-121.347600 °
DWR ID	DWR_RD0544_02_f_2017_89				
Comment Code					
Inspector Comment					
Levee Evaluation Comments					
Description:Slope protection repairs are needed along the waterside slope due to erosion and riprap displacement from high water. Based upon levee inspections, it was determined the waterside levee slope is eroding, deteriorating, and degrading. The eroded levee sections need to be restored back to design standards to prevent further deterioration and damage.					
Site ID No:549					
Site Designation:LMA-455					
Repair Type: Erosion					
Rating:Area of Concern					
Field Date:8/18/2017					
Notes:

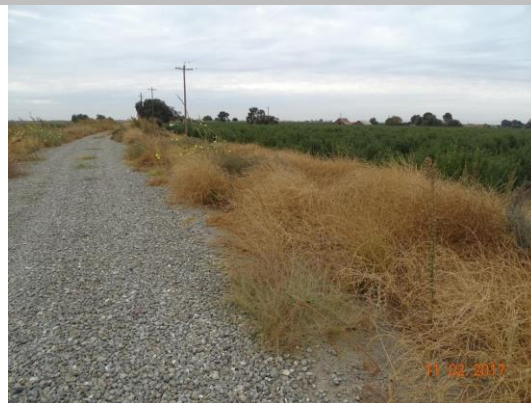
Photo 1 of 1 : SP_2019_RD0544_109_73_20190313_00050.jpg

LM Start	2.41	Rating **	U	Issue No.	73
LM End	2.59	Issue Type +	Ma	Location *	LS
Category	Earthen Levee			GPS Latitude/Longitude	
				Start	End
Item	Vegetation			37.821423 °	37.819153 °
				-121.348849 °	-121.350231 °
DWR ID	DWR_RD0544_02_f_2017_73				
Comment Code					
V2 : Remove the wild growth other than native grasses from the levee slopes.					
Inspector Comment

Looking southwest at the landside slope.

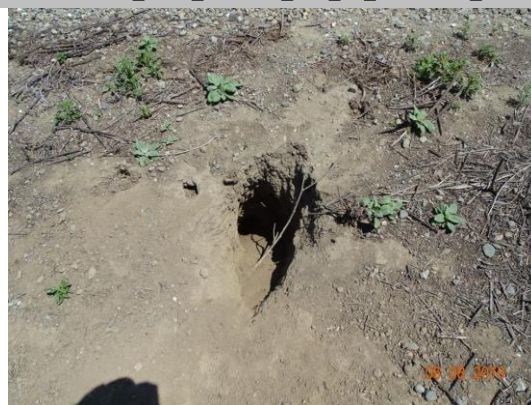
Photo 1 of 2 : SP_2019_RD0544_109_36_20190523_00120.jpg

LM Start	2.43	Rating **	U	Issue No.	36
LM End	2.50	Issue Type +	Ma	Location *	LS
Category	Earthen Levee			GPS Latitude/Longitude	
				Start	End
Item	Animal Control			37.821146 °	37.820286 °
				-121.348992 °	-121.349462 °
DWR ID	DWR_RD0544_02_s_2019_36				
Comment Code					
A3 : No rodents visible, but rodent burrows visible; need to backfill and compact or grout burrows.					
Inspector Comment

View of animal burrow on landside slope. (Spring 2019)

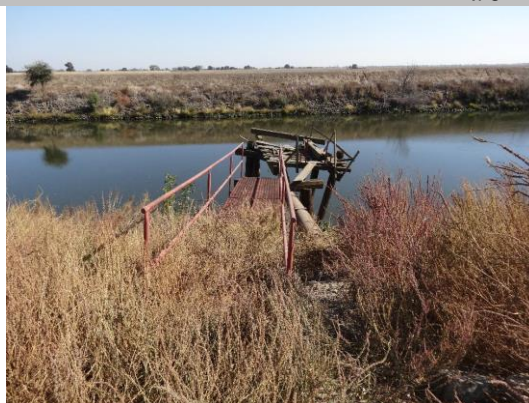
Photo 1 of 3 : UCIP_SP_2019_51381_42972.jpg

Comment Code						
Inspector Comment						
FS_ID:51381 DS_ID:22678 EP_NO: 8625A Repair Type: Non-Urgent Crossing Status: Found UCIP Comments: - abandoned crossing. Needs proper abandonment.- pump removed. Pipe discontinued on landside.- pile structure in dilapalated condon. FIELD_STRUCT_DESC: 16-inch coated steel irrigation discharge pipe through the levee, 7 feet below the crown. Pump mounted on a pile structure in the stream. Siphon breaker on the landside (LS) shoulder. Power pole on the LS slope. (Retention of an existing 16-inch irrigation pipe and pump through the levee authorized under Permit No. 8625-A, 1973 - Irvin Muller). [Additional Reference(s): DWR Levee Log, 2005. USACE San Joaquin O&M Manual 7, April 1964, (HLM 2.65), referenced as 10 feet below the crown]. FS Date: 10/31/2013

WS view: dilapidated walkway and pile structure. Pump removed.

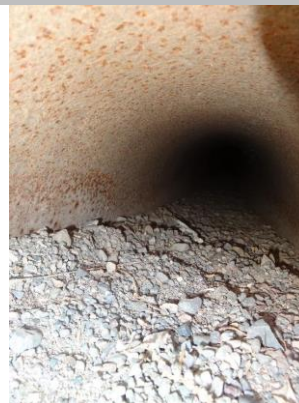
Photo 3 of 3 : UCIP_SP_2019_51381_42970.jpg

LS view: inside view of cut open pipe.

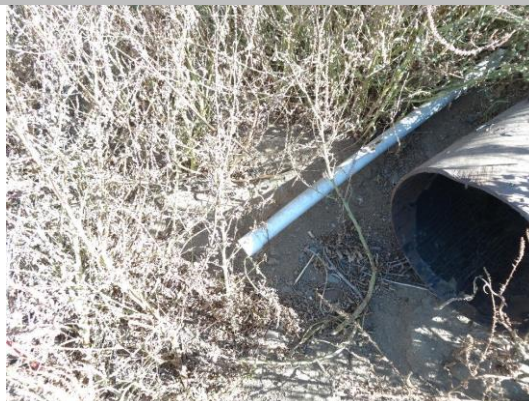
Photo 2 of 3 : UCIP_SP_2019_53173_42976.jpg

LS view: steel pipe and electric conduit on levee shoulder.

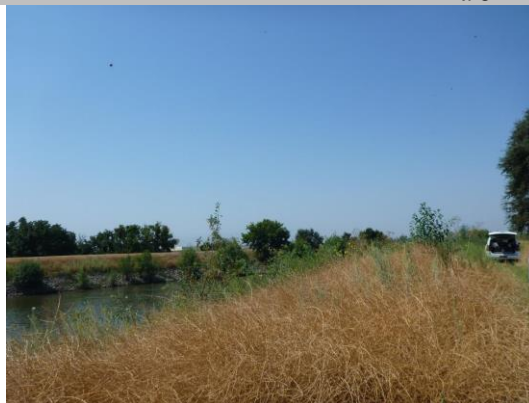
Comment Code					
Inspector Comment					
Levee Evaluation Comments					
Description:Slope protection repairs are needed along the waterside slope due to erosion and riprap displacement from high water. Based upon levee inspections, it was determined the waterside levee slope is eroding, deteriorating, and degrading. The eroded levee sections need to be restored back to design standards to prevent further deterioration and damage.					
Site ID No:547					
Site Designation:LMA-453					
Repair Type: Erosion					
Rating:Area of Concern					
Field Date:8/18/2017					
Notes: levee slopes covered in dense vegetations that hindered visibility.

Comment Code						
Inspector Comment						
Levee Evaluation Comments						
Description:Slope protection repairs are needed along the waterside slope due to erosion and riprap displacement from high water. Based upon levee inspections, it was determined the waterside levee slope is eroding, deteriorating, and degrading. The eroded levee sections need to be restored back to design standards to prevent further deterioration and damage.						
Site ID No:547						
Site Designation:LMA-453						
Repair Type: Erosion						
Rating:Area of Concern						
Field Date:8/18/2017						
Notes: levee slopes covered in dense vegetations that hindered visibility.

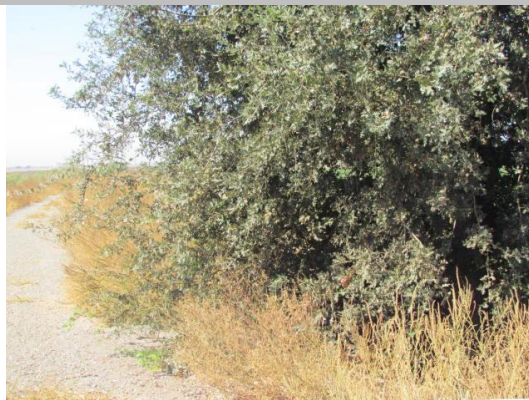
Photo 1 of 1 : SP_2019_RD0544_109_53_20190313_00036.jpg

LM Start	2.80	Rating **	M	Issue No.	53
LM End	2.80	Issue Type +	Ma	Location *	LS
Category	Earthen Levee			GPS Latitude/Longitude	
				Start	End
Item	Trim / Thin Trees			37.817187 °	37.817187 °
				-121.352964 °	-121.352964 °
DWR ID	DWR_RD0544_02_f_2014_53				
Comment Code					
T2 : Thin trees to allow visibility of the ground and room to flood fight.					
Inspector Comment

Looking southwest at untrimmed tree on landward slope fall 2015.

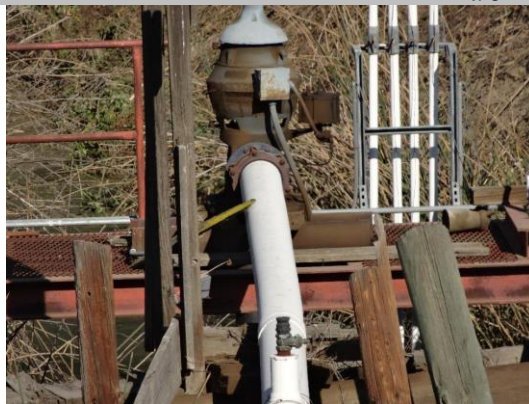
Photo 3 of 3 : UCIP_SP_2019_24908_44896.jpg

LS view: pump on steel platform over drainage ditch.

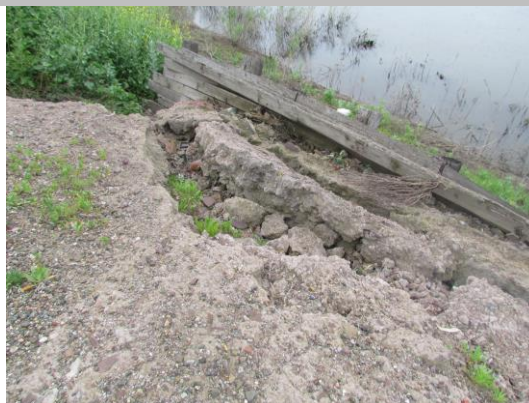
Photo 1 of 1 : SP_2019_RD0544_109_78_20190313_00052.jpg

LM Start	3.25	Rating **	U	Issue No.	78
LM End	3.25	Issue Type +	En	Location *	WS
Category	Earthen Levee			GPS Latitude/Longitude	
				Start	End
Item	Encroachments			37.819347 °	37.819347 °
				-121.360103 °	-121.360103 °
DWR ID	DWR_RD0544_02_s_2017_78				
Comment Code					
RW : Retaining Wall					
Inspector Comment					
Waterside slope retaining wall at pump location has slipped.

Looking east at sloughing of earthen pad on waterward shoulder and slope.

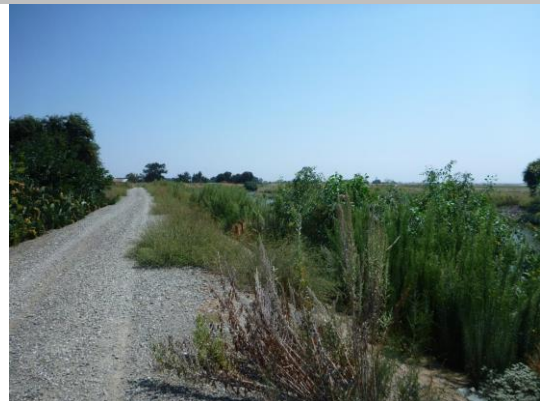
Photo 1 of 3 : LEVAL_SP_2019_544_4781.jpg

LM Start	3.51	Rating **	A/W	Issue No.	94
LM End	3.55	Issue Type +	Ma	Location *	
Category	Supplemental			GPS Latitude/Longitude	
				Start	End
Item	2017 Storm Damage			37.819500 °	37.819400 °
				-121.364700 °	-121.365400 °
DWR ID	DWR_RD0544_02_f _ 2017_94				
Comment Code					
Inspector Comment					
Levee Evaluation Comments					
Description:Slope protection repairs are needed along the waterside slope due to erosion and riprap displacement from high water. Based upon levee inspections, it was determined the waterside levee slope is eroding, deteriorating, and degrading. The eroded levee sections need to be restored back to design standards to prevent further deterioration and damage.					
Site ID No:544					
Site Designation:LMA-450					
Repair Type: Erosion					
Rating:Area of Concern					
Field Date:8/18/2017					
Notes:

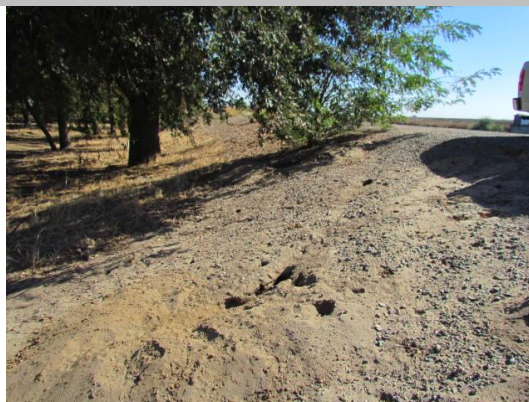
Photo 1 of 2 : SP_2019_RD0544_109_67_20190313_00039.jpg

LM Start	3.58	Rating **	M	Issue No.	67
LM End	3.58	Issue Type +	Ma	Location *	LS
Category	Earthen Levee			GPS Latitude/Longitude	
				Start	End
Item	Animal Control			37.819419 °	37.819419 °
				-121.365854 °	-121.365854 °
DWR ID	DWR_RD0544_02_f_2015_67				
Comment Code					
A3 : No rodents visible, but rodent burrows visible; need to backfill and compact or grout burrows.					
Inspector Comment					
Large rodent holes on landward slope.

Looking northeast at typical view of rodent holes on landward slope.

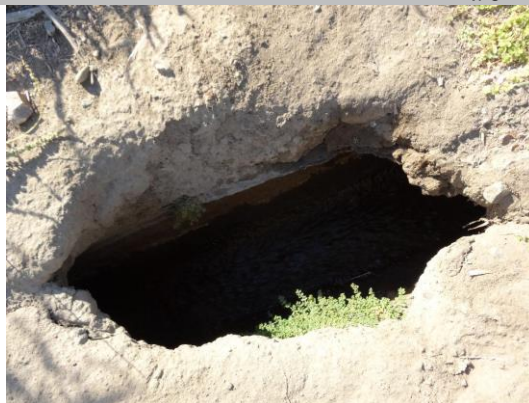
Photo 2 of 3 : UCIP_SP_2019_53367_43004.jpg

UCIP Comments: 10/2/2018 Same as last inspection; WS pipe completely eroded away and therefore poses significant threat to internal levee integrity so crossing remains Urgent (D. Sanoski - DWR UCIP).12/22/2015 Entire top part of pipe on WS corroded through and completely gone. Difficult to see WS due to heavy vegetation. Gully formed on WS slope in alignment with pipe and WS slope is saturated. (K. Fazel - UCIP)06/25/2015 Pipe completely rusted thru on WS slope and has potential to cause great erosion. Pit and holes on pipe and levee. No vent pipe found on WS. No concrete vent pipe found at the LS toe. (K. Fazel - UCIP)

WS view: close view of levee slope with pits and holes.
